## HAZARDOUS MATERIALS ASSESSMENT REPORT

**16 DEEP COVE ROAD  
EASTPORT, MAINE**

**Prepared for: WOOD PLC  
511 Congress Street, Suite 200  
Portland, Maine 04101**

**AUGUST 10, 2020  
JN: 10520.010**

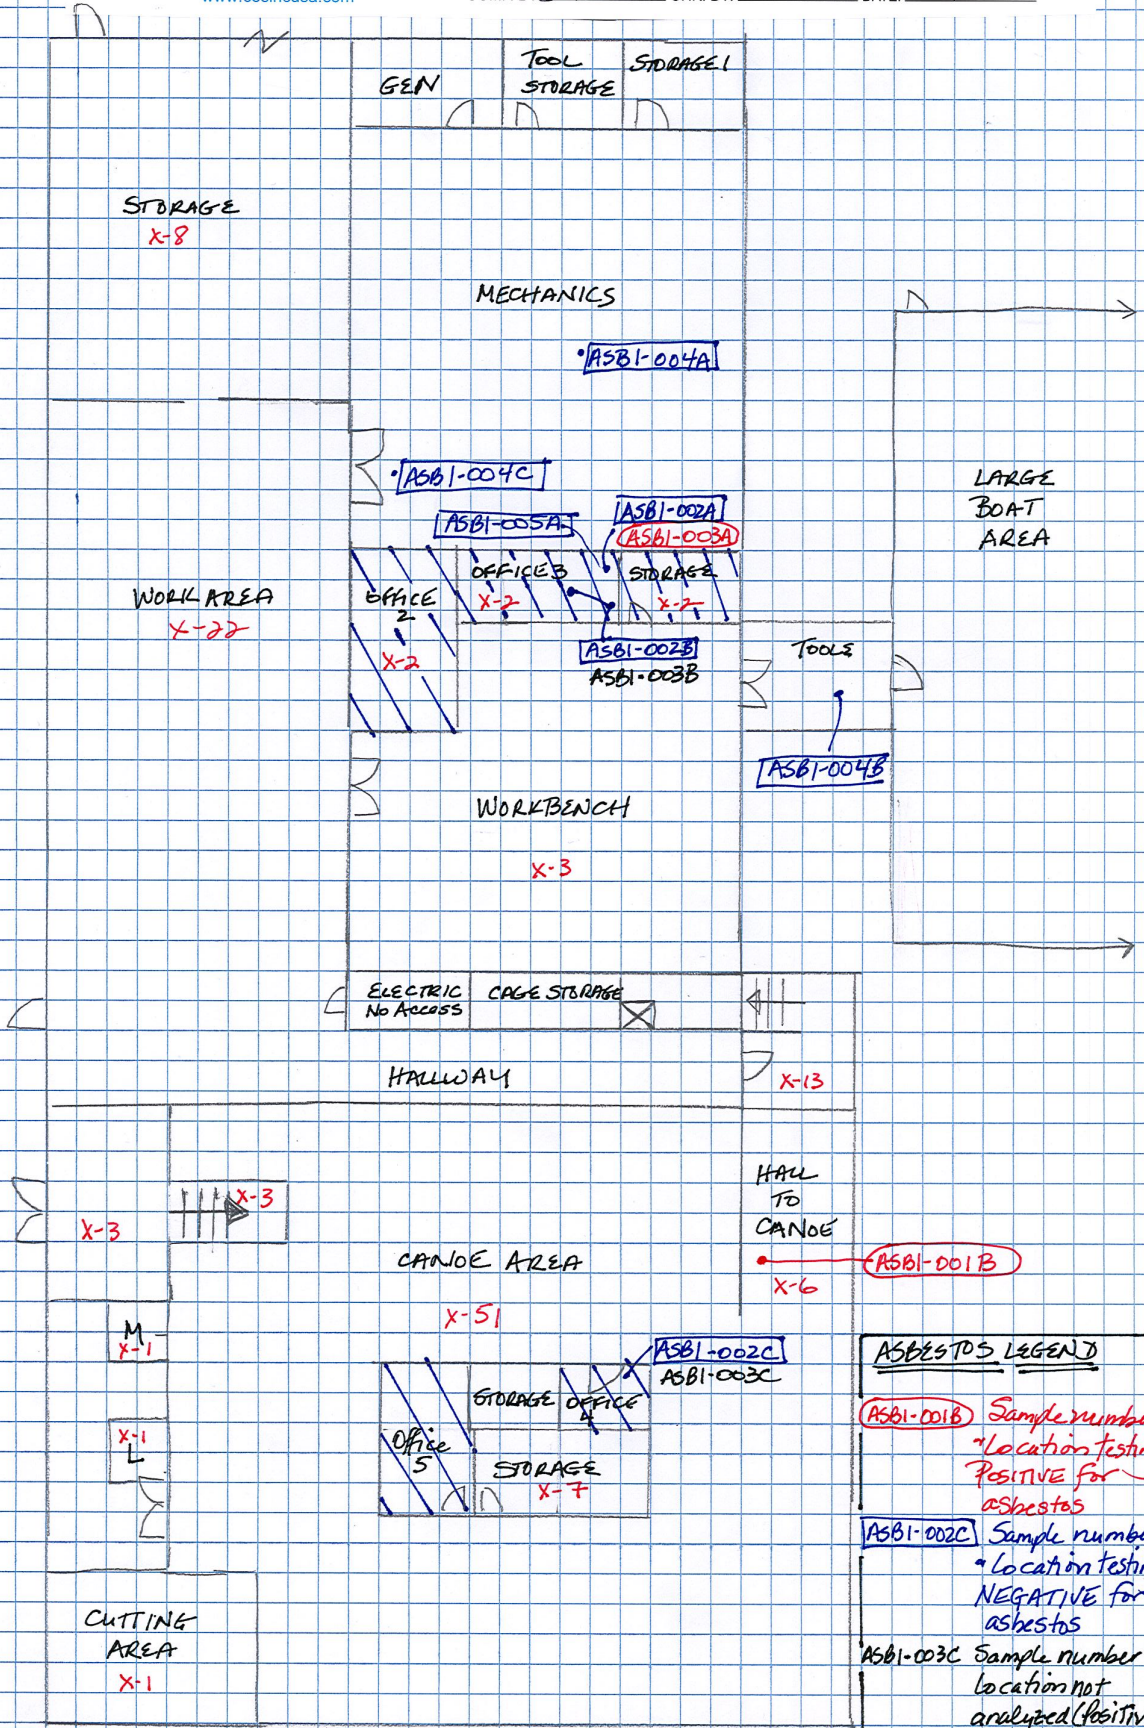
FIGURE H101

- ◆ Mudded pipe fitting insulation (Sample ASB1-001B)
- ◆ Black floor tile adhesive (Sample ASB1-003A)

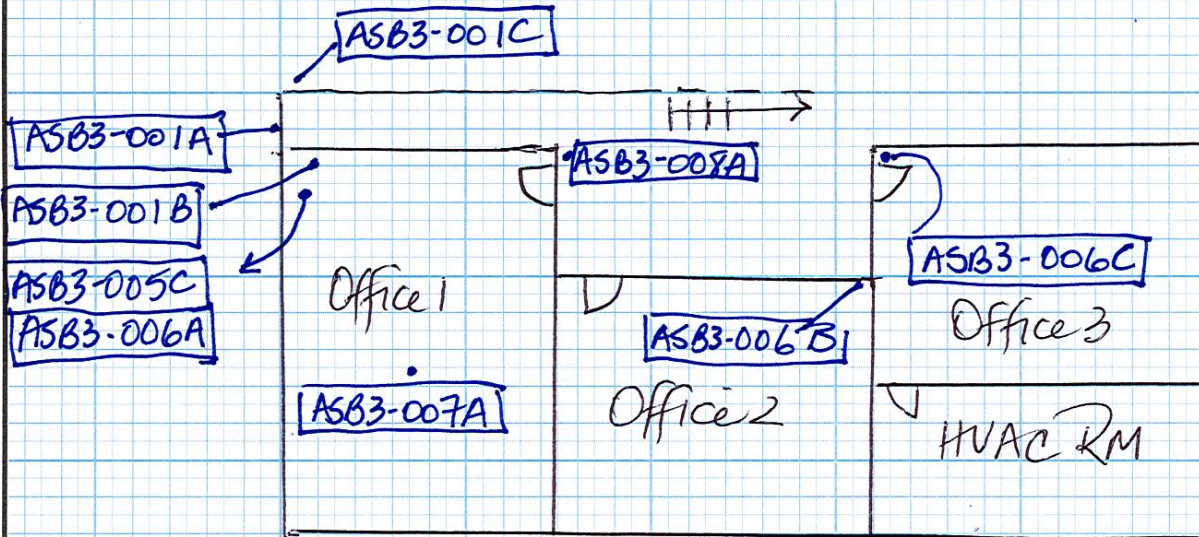
FIGURE H105

- ◆ Mudded pipe fitting insulation (Sample ASB3-0011C)

- ASB3-011C Sample number + Location testing **POSITIVE** for asbestos
- ASB3-001A Sample number + Location testing **NEGATIVE** for asbestos
- X-# ACM insulated pipe fitting

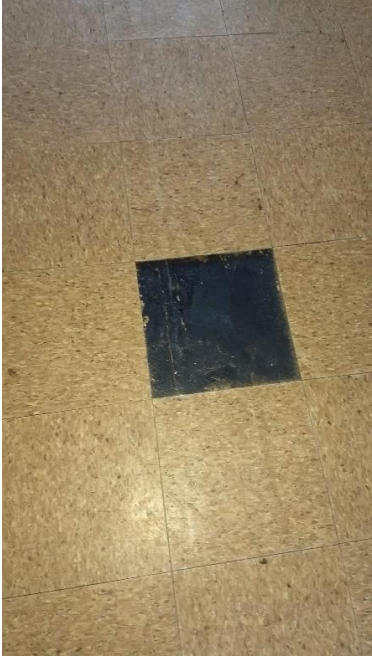
- ◆ Black floor tile adhesive (Sample ASB2-004A)

<b>Photo No.</b> 5
	<b>Photo Date:</b> June 4, 2020
	<b>Site Location:</b> 16 Deep Cove Road Eastport, Maine
	<b>Description:</b> Building 2 – Asbestos- containing black floor tile adhesive in Classroom
	<b>Photo By:</b> DAK

Current State regulations require that identified ACM which may be impacted by planned renovation/demolition activity be removed by a MDEP licensed asbestos abatement contractor in accordance with applicable state and federal regulations prior to disturbance by such planned activities. In accordance with National Emissions Standards for Hazardous Air Pollutants (NESHAP) (40 CFR 61), State of Maine, MDEP, and Asbestos Management Regulations (06-096 C.M.R. ch. 425 (2011)), a contractor conducting any renovation and/or demolition activity that would disturb regulated ACM must: (1) notify the U.S. Environmental Protection Agency (USEPA) Administrator and the MDEP of such activities, (2) use proper removal procedures, (3) use proper engineering controls to limit emissions of asbestos fibers, and (4) utilize proper waste disposal. If any hidden suspect ACM (behind walls, in chases, above permanent ceilings, etc.) is uncovered during renovation or demolition activities, work must be stopped, and the material tested for asbestos content. All ACM must be disposed of in accordance with all applicable state and federal requirements.

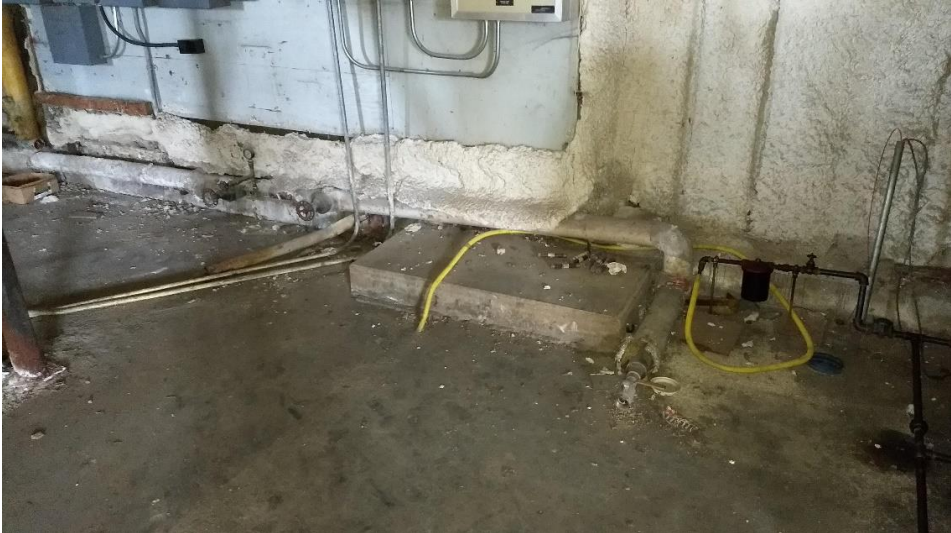
<b>Photo No.</b> 7
	<b>Photo Date:</b> June 4, 2020
	<b>Site Location:</b> 16 Deep Cove Road Eastport, Maine
	<b>Description:</b> Building 3 – Asbestos-containing muddied pipe fitting insulation in boiler room
<b>Photo By:</b> DAK

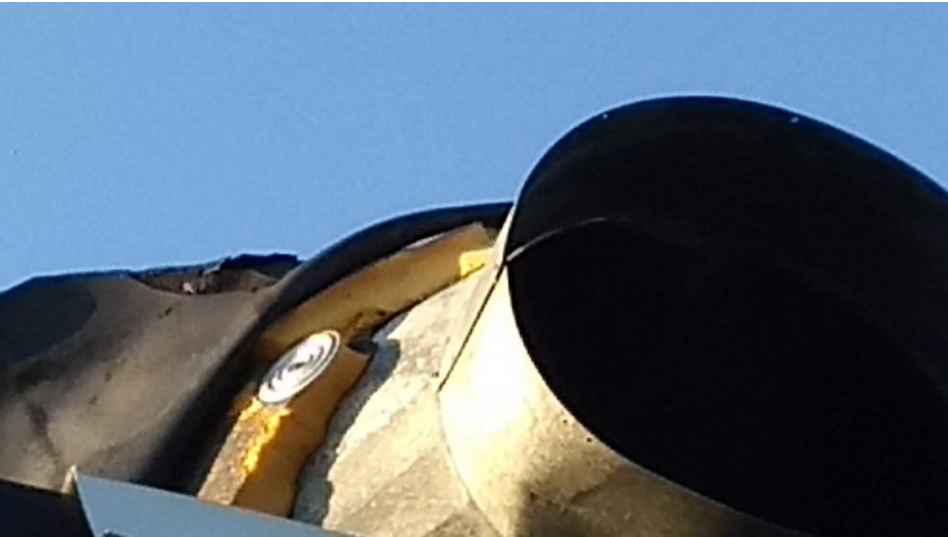
- ◆ Asphalt roof penetration covering with evidence of silver coating associated with Building #1 (Sample ASBE-004A).

<b>Photo No.</b> 12
	<b>Photo Date:</b> June 4, 2020
	<b>Site Location:</b> 16 Deep Cove Road Eastport, Maine
	<b>Description:</b> Exterior – Asbestos- containing asphalt covering on roof penetrations
<b>Photo By:</b> DAK
