## HAZARDOUS MATERIALS ASSESSMENT REPORT

**16 DEEP COVE ROAD  
EASTPORT, MAINE**

**Prepared for: WOOD PLC  
511 Congress Street, Suite 200  
Portland, Maine 04101**

**AUGUST 10, 2020  
JN: 10520.010**

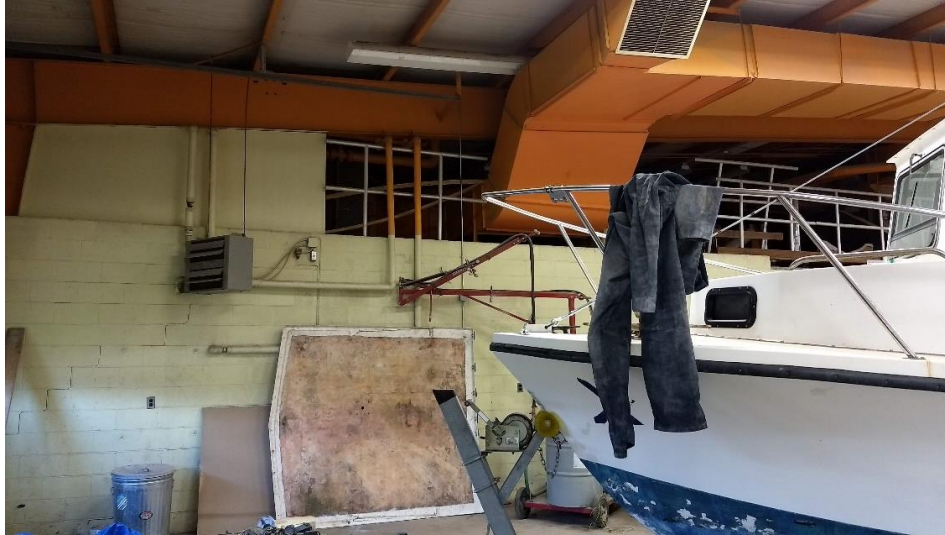
**Photo No. 1**

**Description:**  
Building 1 – Overview  
of Main Level Work  
Area

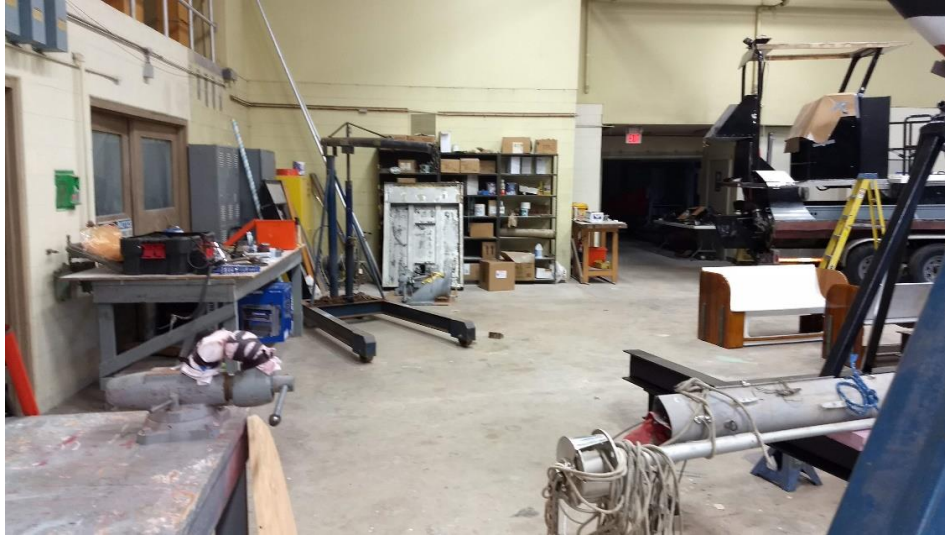
Photo No. 3

Description:  
Building 1 – Painted  
components within the  
main work area

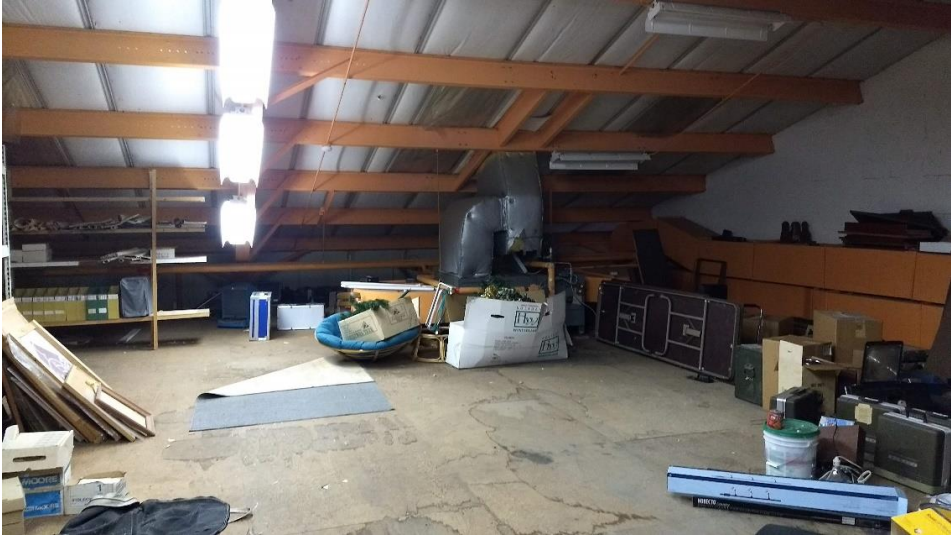
<b>Photo No.</b> 6
	<b>Photo Date:</b> June 4, 2020
	<b>Site Location:</b> 16 Deep Cove Road Eastport, Maine
	<b>Description:</b> Building 2 – Overview of attic space
	<b>Photo By:</b> DAK

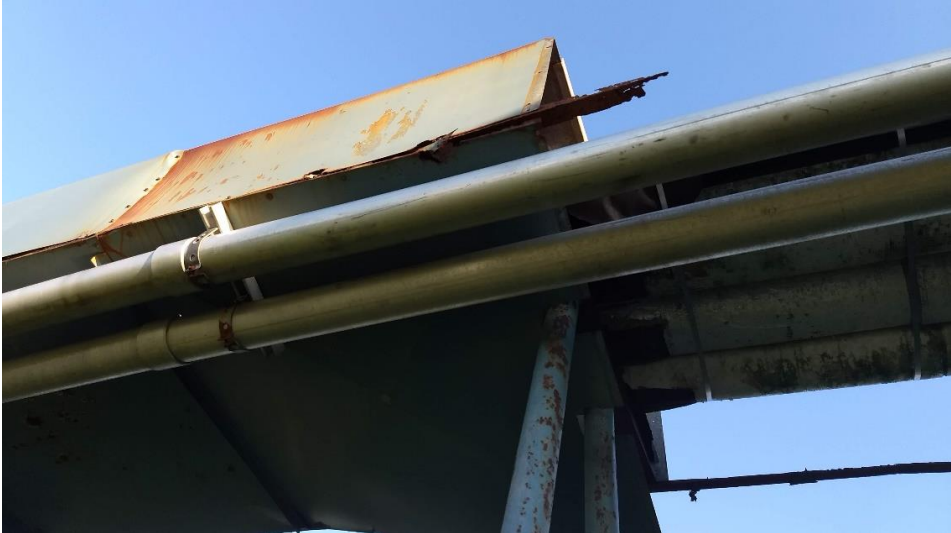
<p><b>Photo No.</b> 9</p>
	<p><b>Photo Date:</b> June 4, 2020</p>
	<p><b>Site Location:</b> 16 Deep Cove Road Eastport, Maine</p>
	<p><b>Description:</b> Exterior – view of pipe bridge (Building 2-Building 1) with metal cover and supports</p>
<p><b>Photo By:</b> DAK</p>
