**ANALYSIS OF BROWNFIELDS CLEANUP ALTERNATIVES**  
**Boat School**  
**16 Deep Cove Road**  
**Eastport, Maine**

**ACRES ID 138601**

Prepared By:  
Campbell Environmental Group  
173 Gray Road, Falmouth, Maine 04105

August 2021

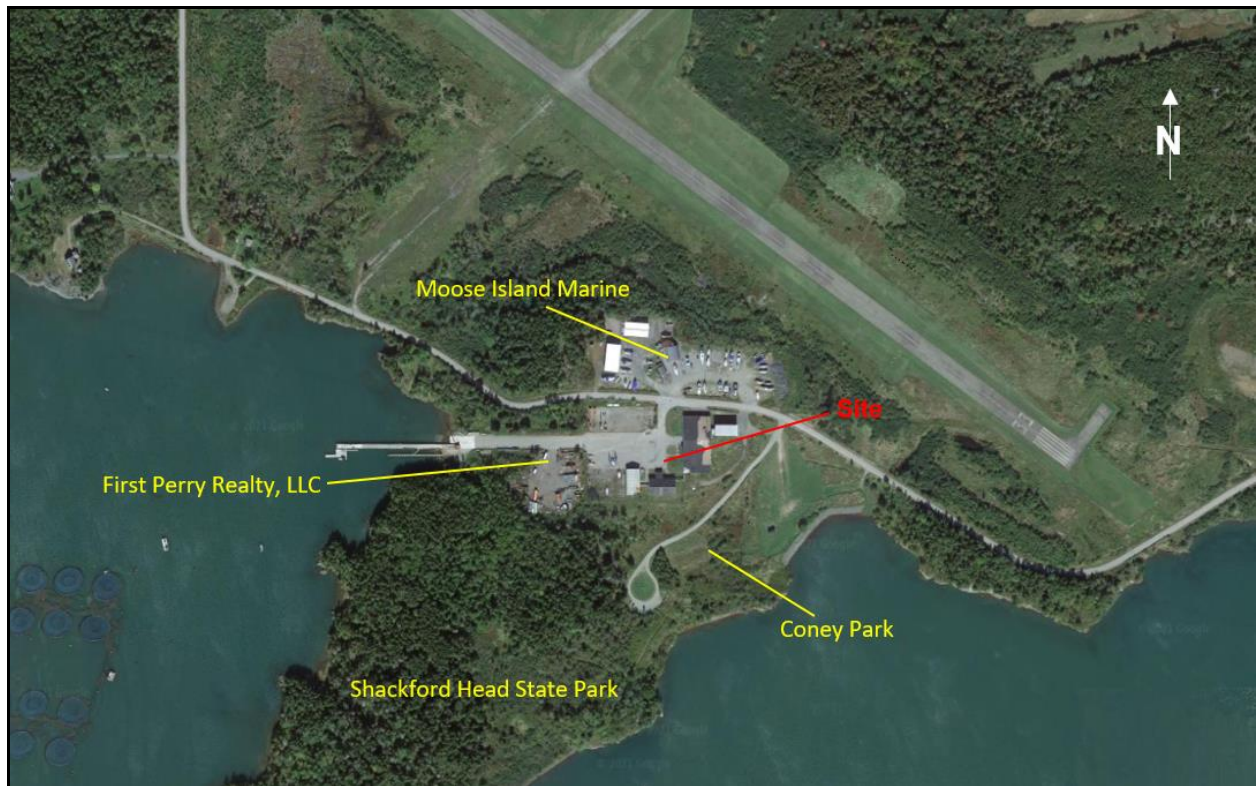
Boat School Site and surrounding area

The surrounding area consists of rural oceanfront property used primarily for commercial and industrial purposes. The Eastport Municipal Airport is located less than 800 feet to the north and northeast of the Site. Moose Island Marine maintains a boatyard and repair facility immediately to the north and west of the Boat School Site. The City of Eastport maintains Coney Park, which consists of oceanfront greenspace to the southeast. Shackford Head State Park is located less than 250 feet to the southwest of the Site.
