ANALYSIS OF BROWNFIELDS CLEANUP ALTERNATIVES
Boat School
16 Deep Cove Road
Eastport, Maine

Prepared for:
Friends of the Boat School Marine Trades Development Corporation
16 Deep Cove Road, Eastport, ME 04631

Prepared By:
Campbell Environmental Group
173 Gray Road, Falmouth, Maine 04105

June 2024

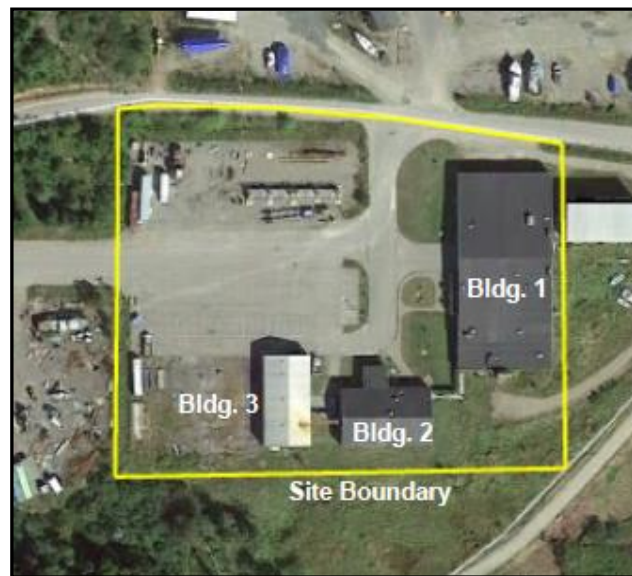
Boat School Site Diagram

The Boat School Site, also known as the Marine Trade Center Site, consists of an approximately 8.4-acre parcel located at 16 Deep Cove Road, in Eastport, Maine (Site). Currently owned by the nonprofit organization Friends of the Boat School Marine Trades Development Corporation, the Site includes three buildings and is identified by the City of Eastport on Tax Map I4 as lot A5-01. Building #1 is located at the northeast corner of the Site and consists of a single-story metal structure constructed on a concrete slab. The building is approximately 21,000 square feet in size and was previously used for boat storage and maintenance as well as classroom space. Building #2 is located in between Building #1 and #3, and consists of a 6,400 square foot two-story metal structure also constructed on a concrete slab. Building #2 was historically used for various academic and administrative purposes and includes office space, a library, and an expansive community room similar to a large classroom or cafeteria. The facility's third building (Building #3) is also constructed on a concrete slab and features metal siding. Building #3 is approximately 4,800 square feet in size and houses a former laboratory as well as the facility's boiler room, maintenance area, and attic loft space. The Boat School Site is currently unused, however, the intent is to redevelop the property as a post-secondary technical education center for marine trades.

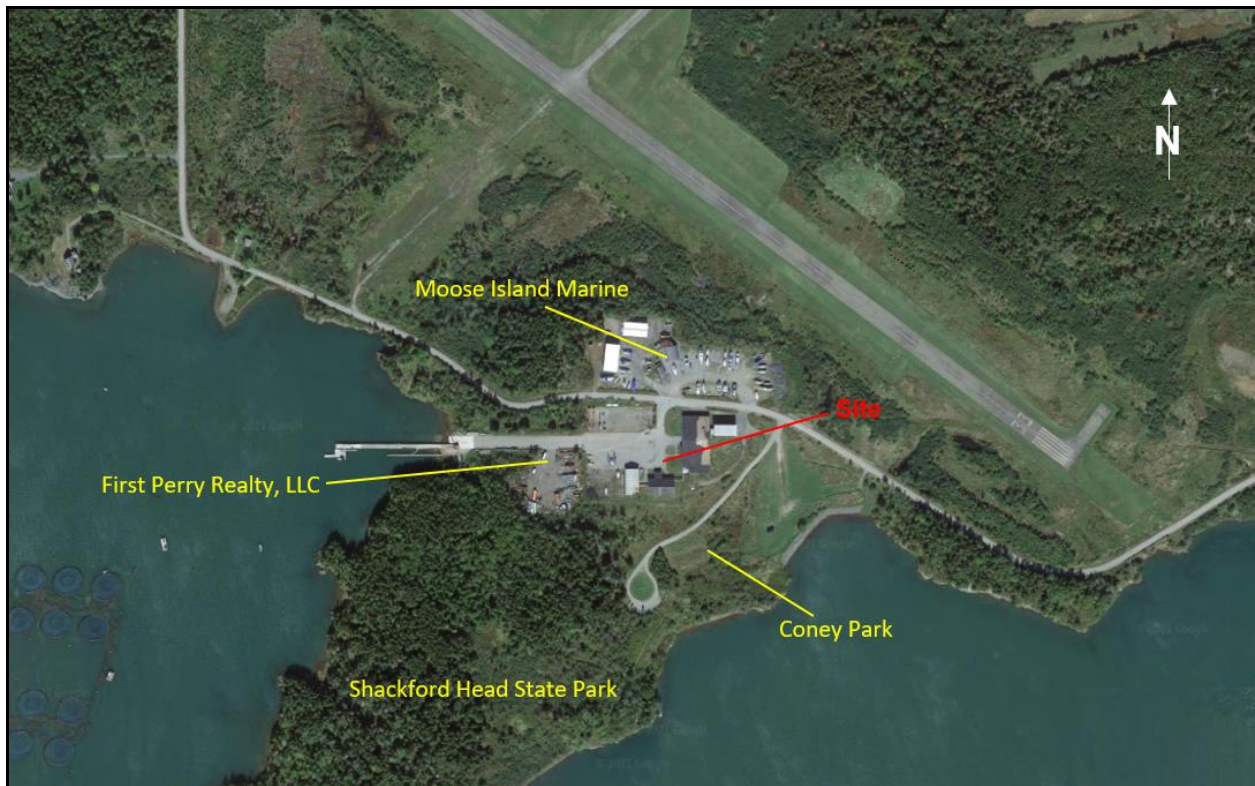
Boat School Site and surrounding area

The surrounding area consists of rural oceanfront property used primarily for commercial and industrial purposes. The Eastport Municipal Airport is located less than 800 feet to the north and northeast of the Site. Moose Island Marine maintains a boatyard and repair facility immediately to the north and west of the Boat School Site. The City of Eastport maintains Coney Park, which consists of oceanfront greenspace to the southeast. Shackford Head State Park is located less than 250 feet to the southwest of the Site.
